Media Release – CUT TO SIZE PLASTICS – February 2017

Cut To Size's creative solution solves Clean In Place pump service life issue for Euro Pumps

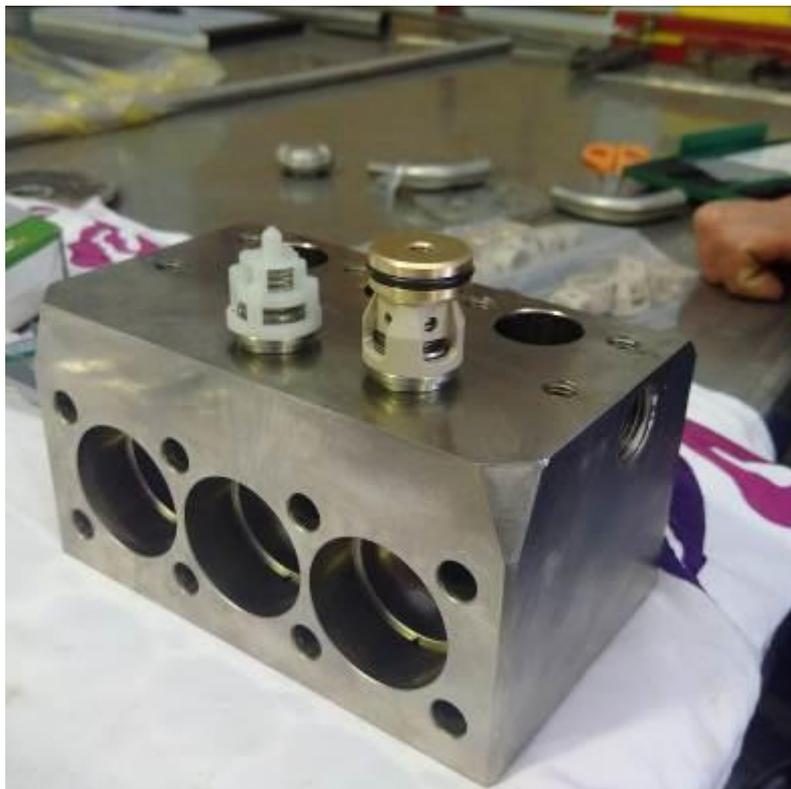
New valve cages (left) were wearing out far too quickly. New high-performance valve cages (right) suggested by Cut To Size Plastics were a welcomed solution

"After examination of the original cages, material identification and a check for chemical compatibility with common additives to water, Cut To Size identified that the failure was due to accelerated chemical degradation due to the elevated heat in a chemical environment and not just heat, as was first suggested," she explained.

Cut To Size recommended a special high performance polymer to solve the problem. This test polymer was highly successful and has passed a standard service life test of 1,000 hours. Further testing is still under way and both parties are expecting it to far exceed the standard 1,000 hours.

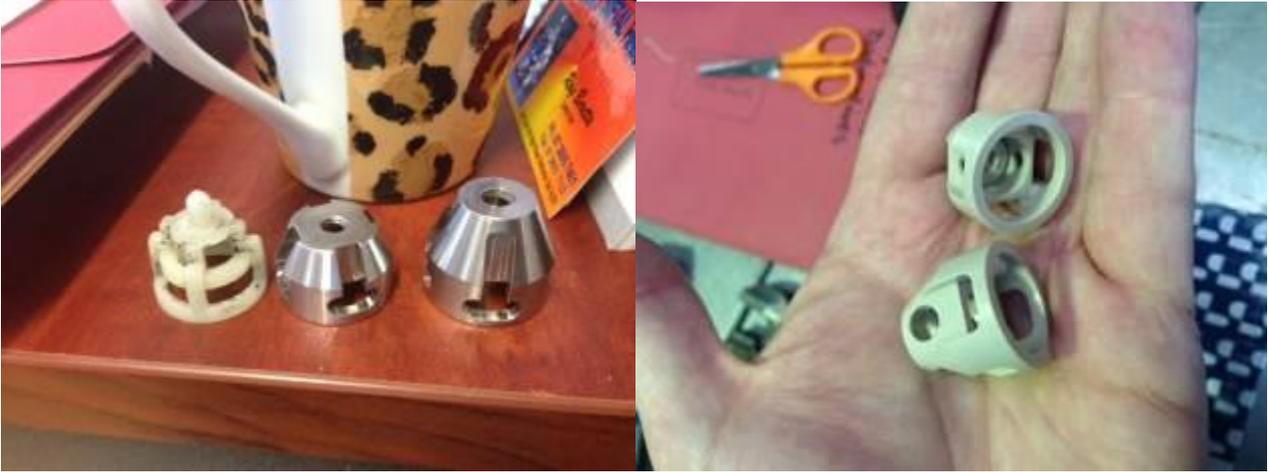
The initial solution attempt was to custom manufacture new valve cages from stainless steel, which brought about other issues causing the stainless-steel springs to break and fail. Further investigations showed that the spring breakage was attributed to the stainless steel binding on stainless steel, so the solution was electro-coat the springs, however this did not prove to be a long-lasting solution as the coating quickly wore off.

Old Nylon Valve cages and the stainless steel solution (left) and Cut To Size's new special high performance polymer for Euro Pumps' pump valves (right)
